Chemical Engineering 412

Introductory Nuclear Engineering

Lecture 26 Commercial Nuclear Accidents

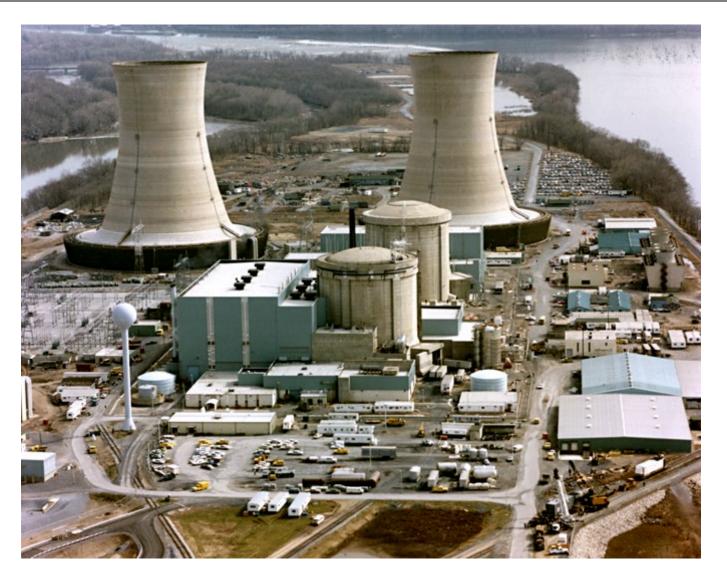
Three Mile Island

March 28, 1979 - South of Harrisburg – Capital of Pennsylvania

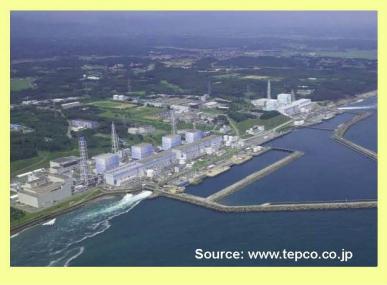
Fukushima Dai-ichi NPP

- Epicenter location: 38° 6"N and 142° 51"E, and 24km in depth
- It is said that the height of tsunami attacked Fukushima NPP was more than 14m

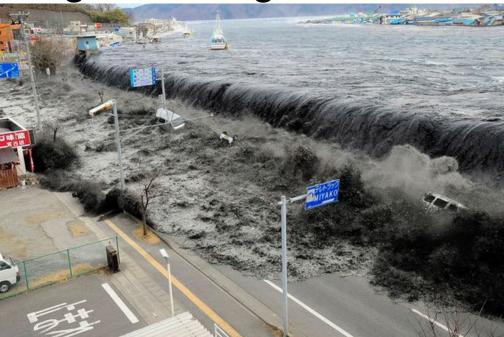
The Real Catastrophe was the Tsunami

- 26,000 (dead &missing) & 130,000 homeless (April 28, 2011)
- Lead four plants at Fukushima I to fuel damage and large releases of radiation

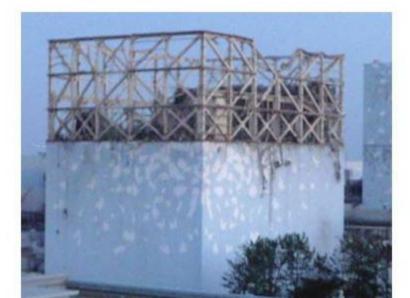
Hydrogen Explosion Units 1 & 3

- Hydrogen burn inside the reactor service floor
 - Destruction of the steel-frame roof
 - Reinforced concrete reactor building seems undamaged
 - Spectacular but minor safety relevant

Unit 1 reactor building; top portion damaged from earlier explosion

Unit 3 reactor building; steam is no longer visible venting from the building
