# Chemical Engineering 412

Introductory Nuclear Engineering

Lecture 35 Nuclear Accidents

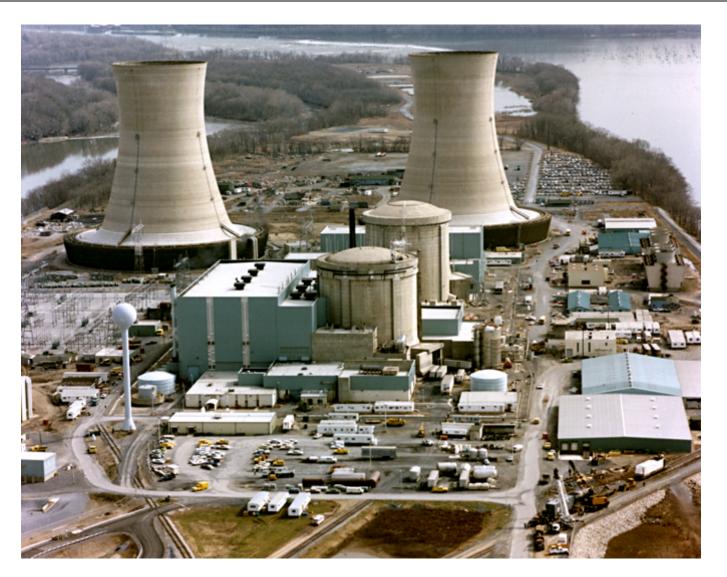
#### **Three Mile Island**

March 28, 1979 - South of Harrisburg – Capital of Pennsylvania

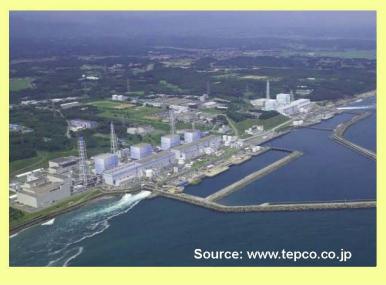
#### Fukushima Dai-ichi NPP

- Epicenter location: 38° 6"N and 142° 51"E, and 24km in depth
- It is said that the height of tsunami attacked Fukushima NPP was more than 14m

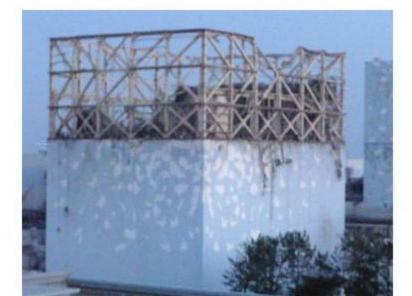
# Hydrogen Explosion Units 1 & 3

- Hydrogen burn inside the reactor service floor
- Destruction of the steel-frame roof
- Reinforced concrete reactor building seems undamaged
- Spectacular but minor safety relevant

Unit 1 reactor building; top portion damaged from earlier explosion

Unit 3 reactor building; steam is no longer visible venting from the building
